Historic Building
Wales

Lift Restored For Grade Listed Building

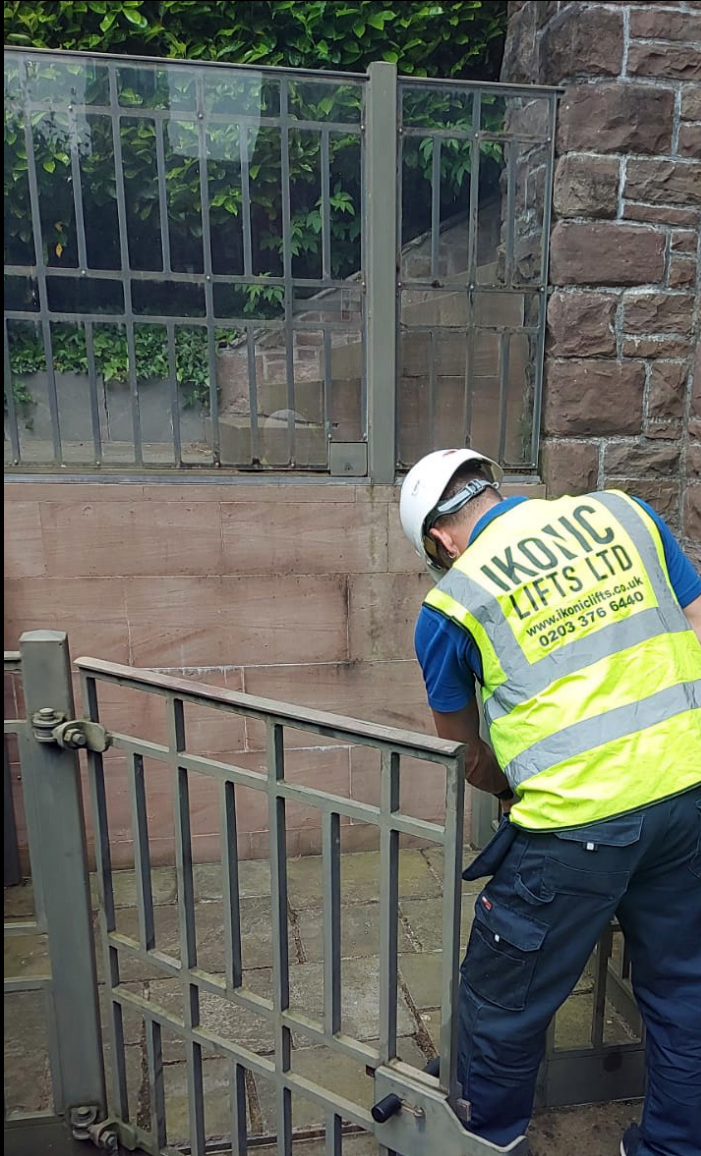
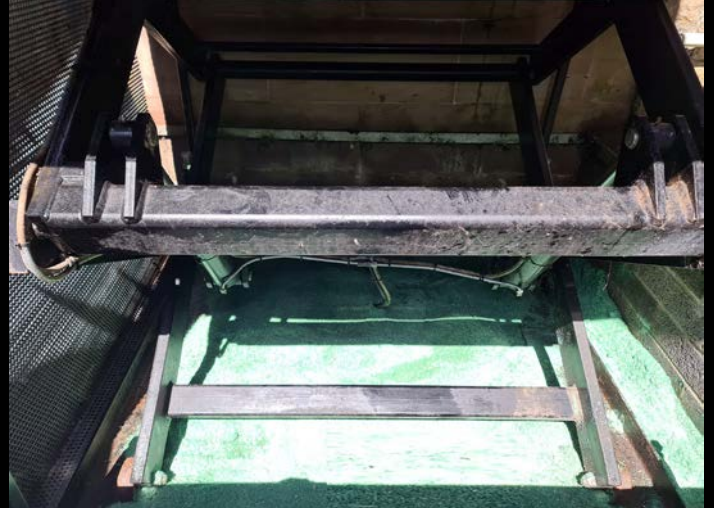
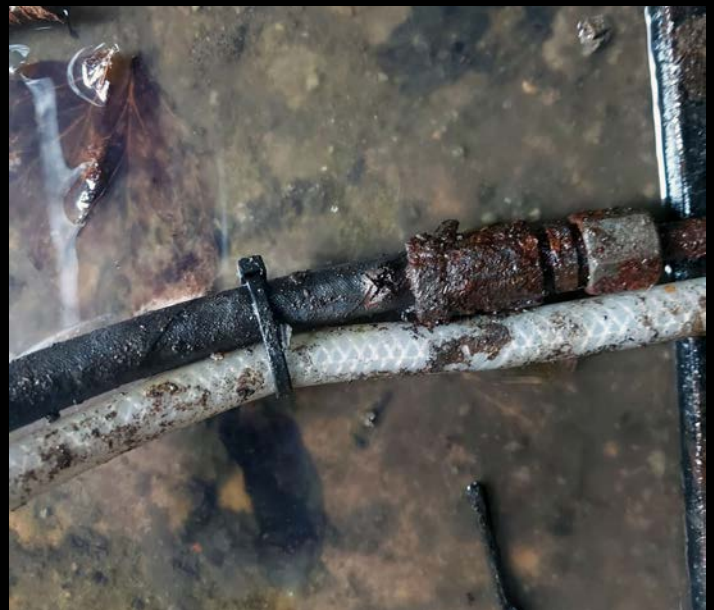
As anticipated, the hose was corroded and burst. We removed the hose and had a replacement made.

Our project manager scheduled the repairs so they could be completed within the timeframe available. Arranged for a 3 ton A frame to be on site.

Our engineers hoisted the lift into the air and put safety props in place. In order to dry out all the oil spill, they coated the pit with a soak spill kit.

Our engines safely installed the replacement hose and refilled the oil tanks. The oil spill kit was cleaned and the lifting equipment removed.

The lift was checked and then tested for 30 minutes to ensure the repair was completed and no further issues were presents.

We advised our client that in order to prevent this from happening in the future, a drainage solution should be installed in the pit.

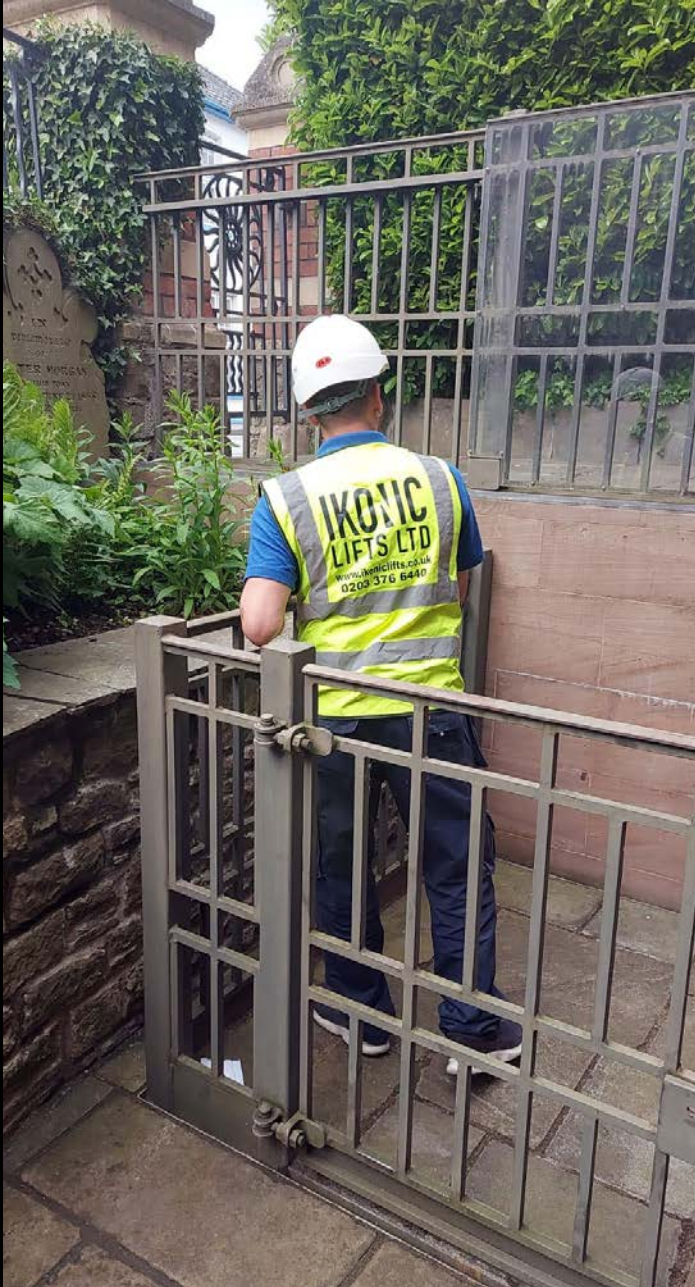
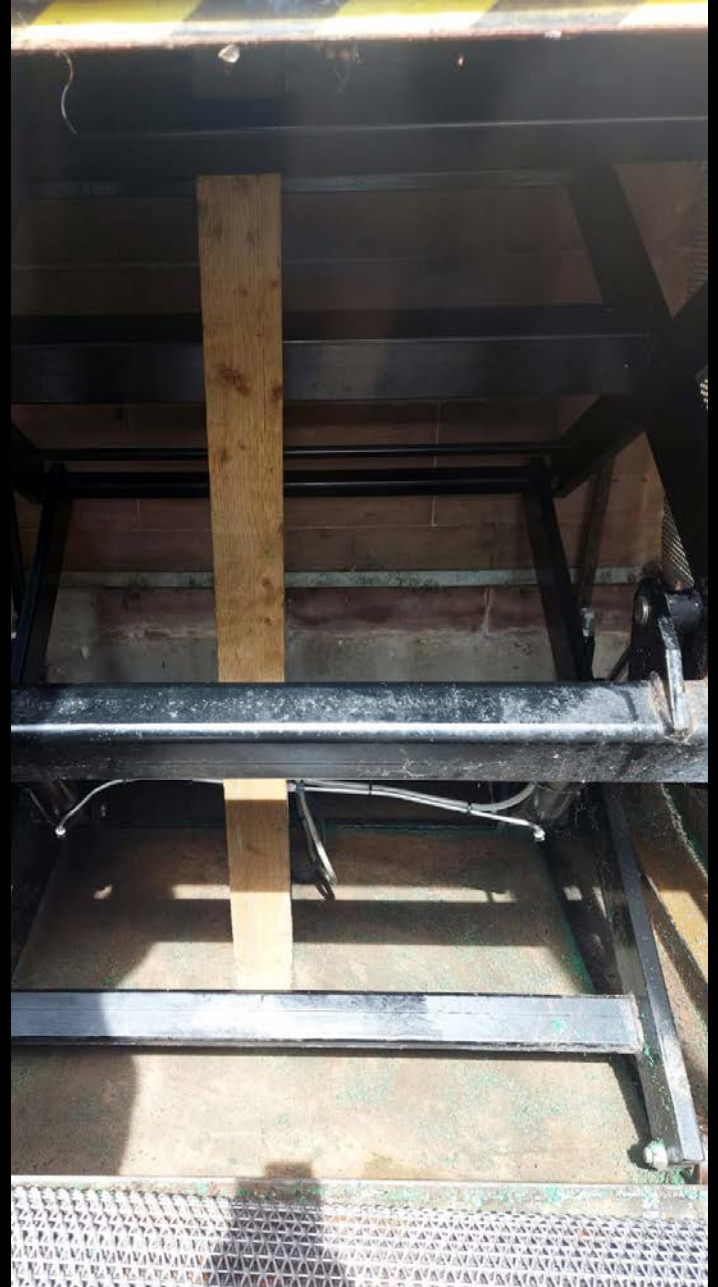
Due to our project manager and engineers, we were able to locate the issue and fix the lift in two visits.

Most importantly the external lift was working in time for the clients event, providing accessibility to their restaurant and complying fully with DDA.
